# Manhole Inspection Summary

Manhole # S150O1014MH

Insp Date: **11/18/06 8:53 AM**

**Location** Address: **4891 YELLOWWOOD AVE** Cross Street: **SUNDEW TERR**

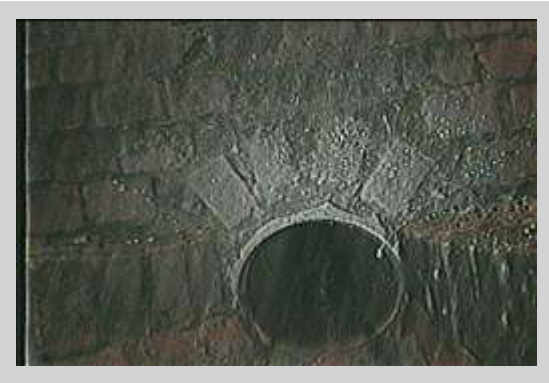
### 8 in. Circular Gravity Sewer Pipe Out @ 12 O'Clock

Pipe Material: **Clay** ☐ Pipe Lined

Invert Depth: **9.84** (ft.) Flow Characteristics: **Fast**

Deposits: ☒ None ☐ Mud ☐ Sludge ☐ Debris ☐ Grease

Infiltration: **None** Pipe Seal Cond: **Unknown**

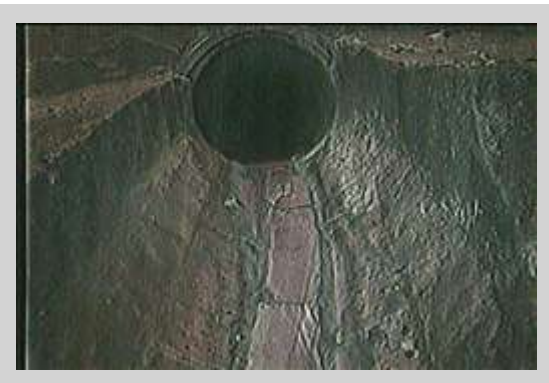
### 8 in. Circular Gravity Sewer Pipe In @ 6 O'Clock

Pipe Material: **Clay** ☐ Pipe Lined

Infiltration: **None** Pipe Seal Cond: **Unknown**
